Subject: Pre-Blasting Survey of the Swapp and Sorenson Ranch; Alton Coal Development LLC,
Coal Hollow Mine, C/025/0005

PRE-BLASTING SURVEY
SORENSEN RANCH
FOR
ALTON COAL DEVELOPMENT, LLC
COAL HOLLOW MINE

BY
DAN W. GUY, P.E.
AUGUST 2, 2011

SORENSEN RANCH

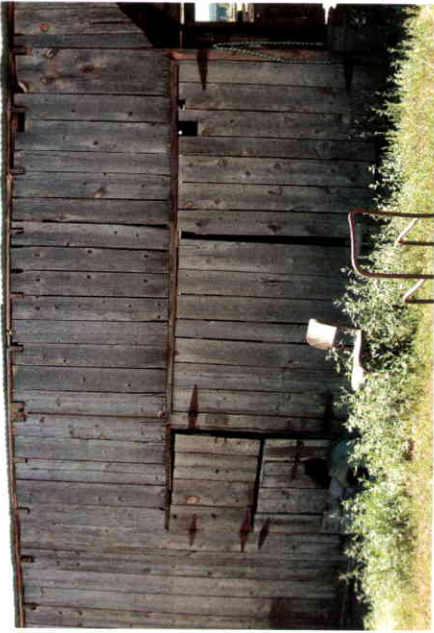
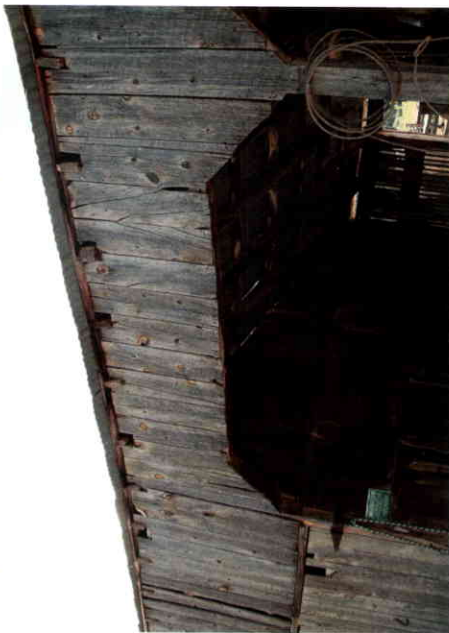
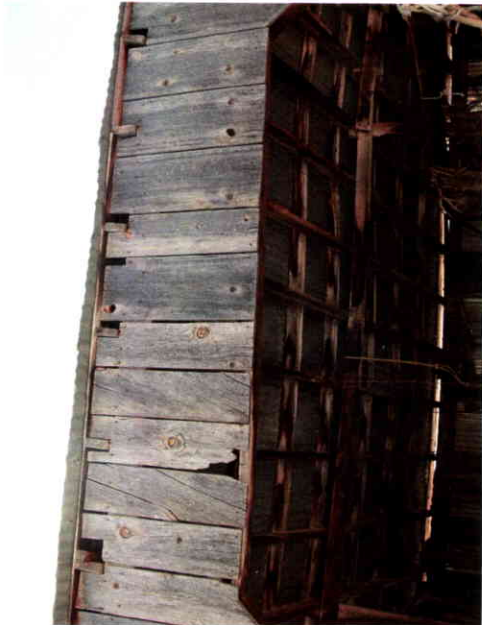
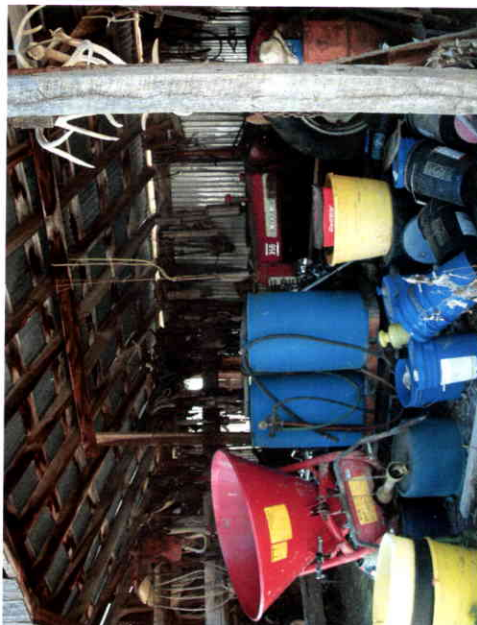
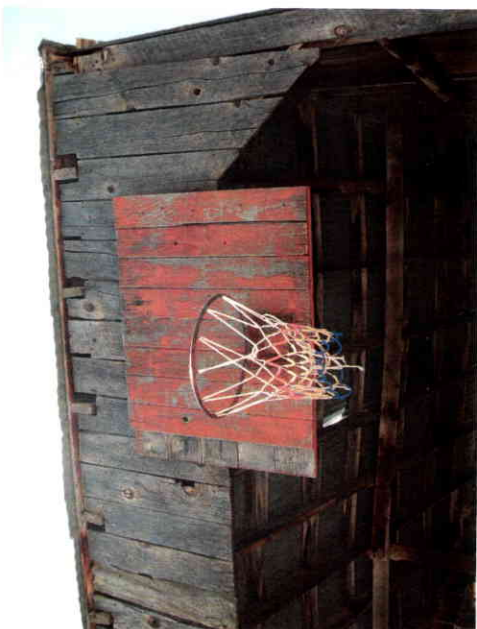
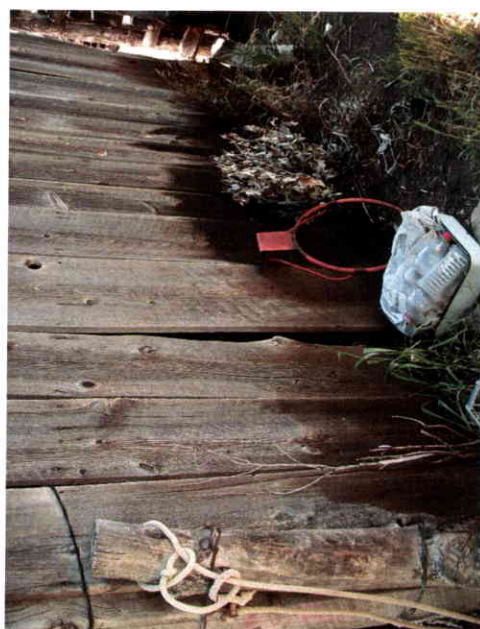
PLATE 16

accumulations of snow with no serious damage. It does show signs of extreme weathering, but no structural failure. The condition is best determined by the photos in Plates 16 and 17.

Plate 16-Shed / Garage

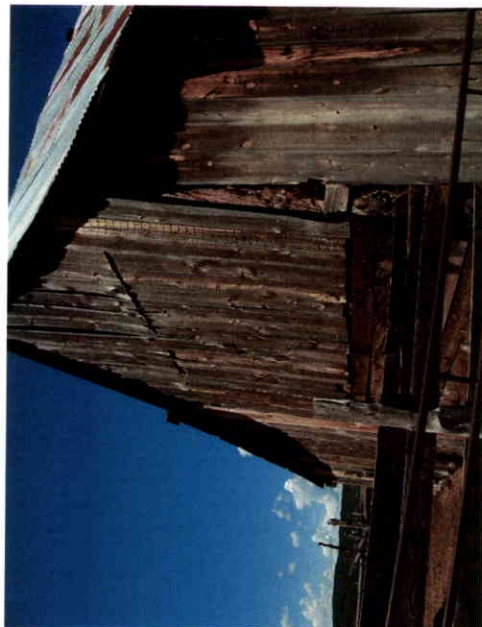
PLATE 18

Barn – This structure is also wood construction with a dirt floor and no foundation. It does have a galvanized tin roof. As with the adjacent shed / garage, it shows a considerable amount of age and weathering. It also appears to be of substantial construction, and although there are a number of gaps in the wood siding and some slumping of the large doors, there doesn't appear to be any structural failure. Photos of the barn are shown on Plate 18.

Plate 18- Barn

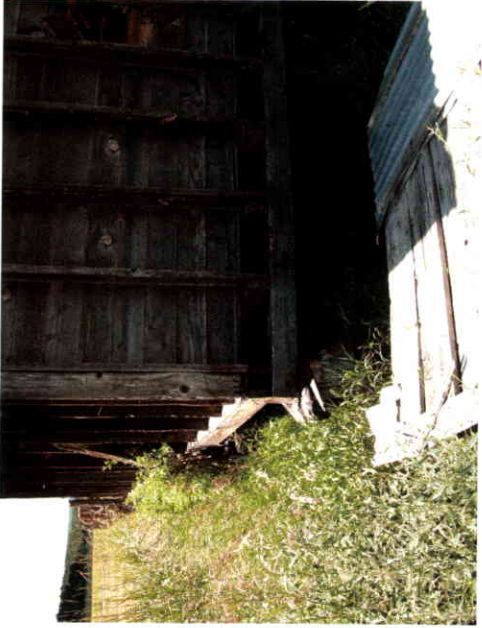
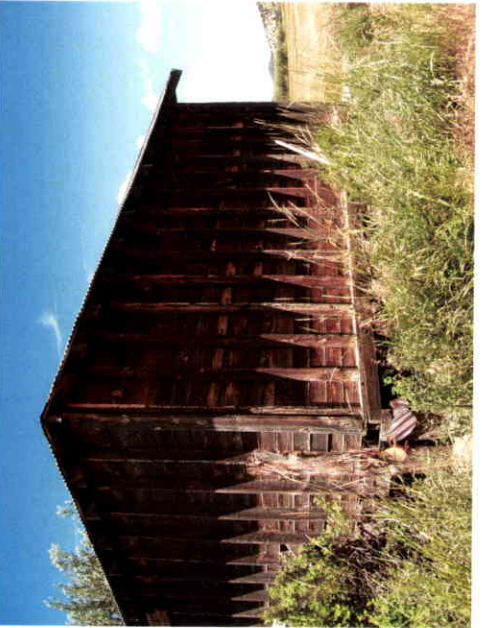
PLATE 19

Granary – The granary is located southeast of the ranch house, as shown on Plates 1 and 2. It is also of wood construction with no actual foundation, although the entire structure is elevated and sits on wood blocks. It has a wood floor and tin on the bottom of the building to keep out rodents. It appears to be well built and shows no sign of structural failure, although the exterior is extremely weathered. The elevated wood block supports do show some tilting in spots, but the building still appears level and stable at this time. Photos of the exterior of the granary are shown on Plates 19 and 20.

Plate 19-Granary

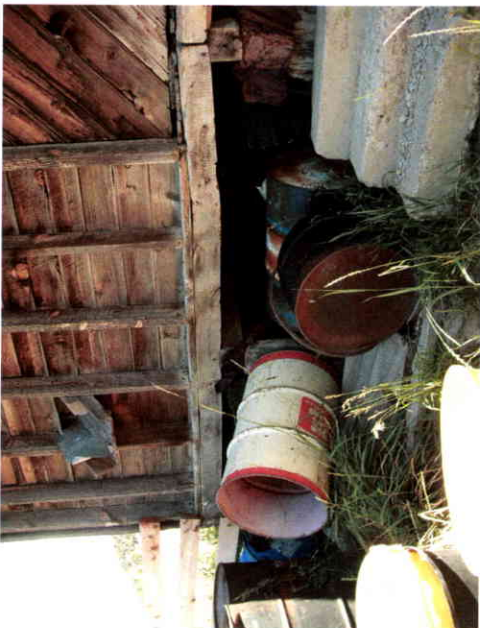
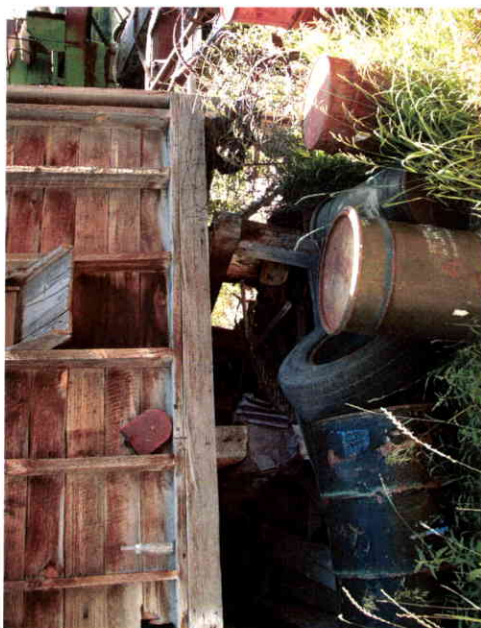
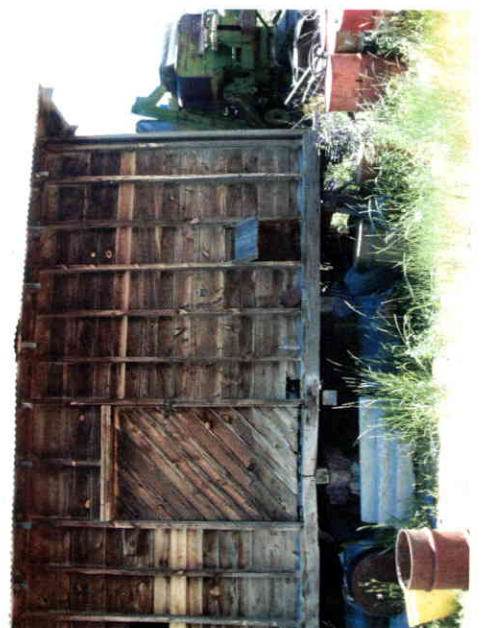
PLATE 20

Plate 20-Granary

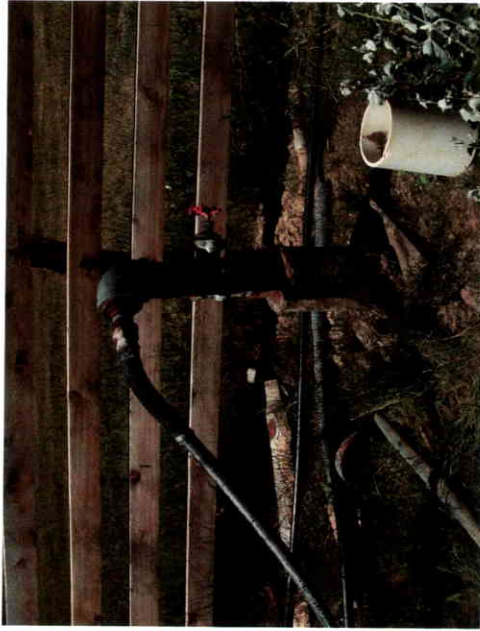
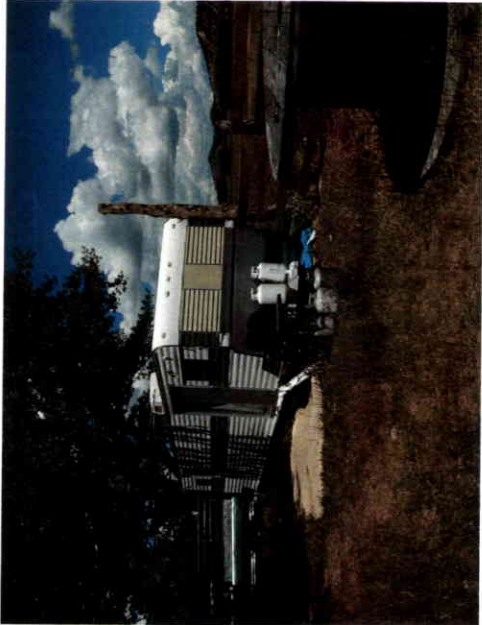
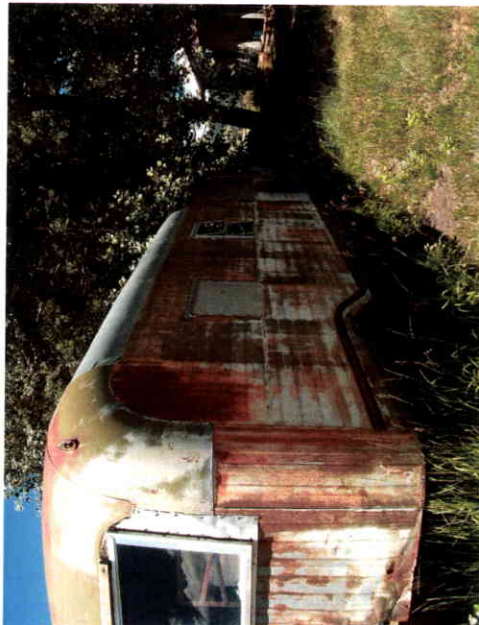
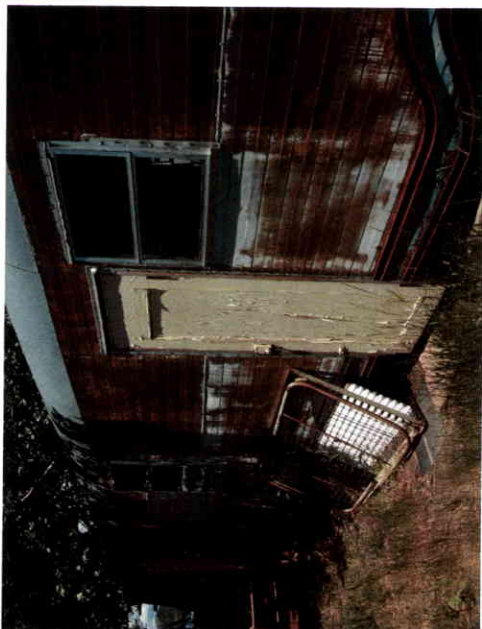
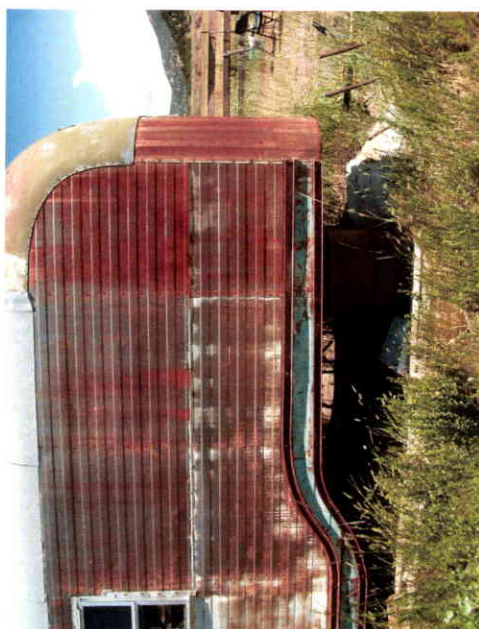
PLATE 21

Trailers – There are 2 trailers on the site. One is a newer mobile home, and was only documented in a photo. It is sitting on wheels, and has little, if any, potential for damage from blasting. The other trailer is an older 5th Wheel type trailer supported by steel drums and elsewhere by wooden blocks. The owner referred to this trailer as the "Motel". Once again, there is little, if any, potential for damage to this trailer from blasting. The condition of both trailers can be seen on Plate 21.

livestock on the site. It should be noted that this well is monitored on a regular basis by a hydrologist working for Alton Coal Development, LLC. Any damage or decrease in flow from this well would best be determined by the hydrologic monitoring. The exposed portion of the well is shown on Plate 21.
